[별첨1] 측정 위치도(측정 장소)

제1공학관 외 3동 석면철거공사 <이학관>

제1공학관 외 3동 석면철거공사 <산학연구원>

제1공학관 외 3동 석면철거공사 <제1공학관>

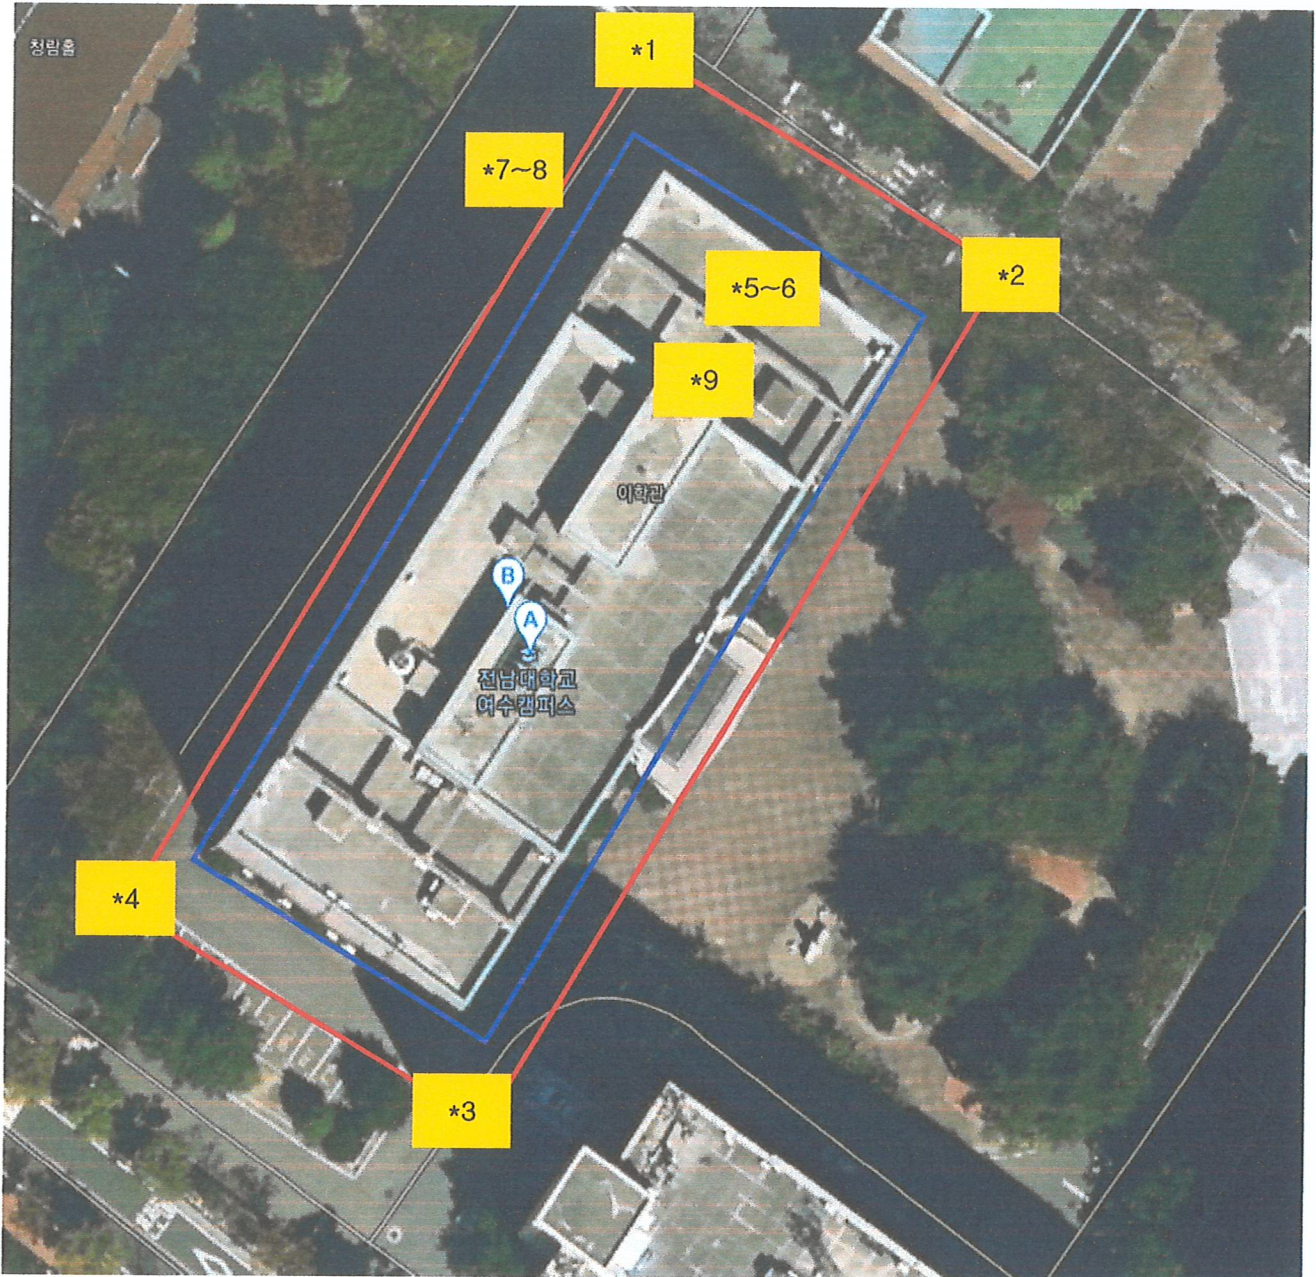
시료 번호	측정 지점	측정 장비 (종류/수량)		유량 (ℓ/분)	측정 일시	측정 결과 (f/cc)	비고
1	부지경계선1	지역시료채취펌프 (SARA-5100)	1	10.00	20/06/18	불검출 [검출한계 0.002미만]	—
2	부지경계선2	지역시료채취펌프 (SARA-5100)	1	10.00	20/06/18	불검출 [검출한계 0.002미만]	—
3	부지경계선3	지역시료채취펌프 (SARA-5100)	1	10.00	20/06/18	불검출 [검출한계 0.002미만]	—
4	부지경계선4	지역시료채취펌프 (SARA-5100)	1	10.00	20/06/18	불검출 [검출한계 0.002미만]	—
5	위생설비입구	지역시료채취펌프 (SARA-5100)	1	10.00	20/06/18	불검출 [검출한계 0.002미만]	—
6	작업장주변	지역시료채취펌프 (SARA-5100)	1	10.00	20/06/18	불검출 [검출한계 0.002미만]	—
7	음압기배출구1	지역시료채취펌프 (SARA-5100)	1	10.00	20/06/18	불검출 [검출한계 0.002미만]	—
8	음압기배출구2	지역시료채취펌프 (SARA-5100)	1	10.00	20/06/18	불검출 [검출한계 0.002미만]	—
9	폐기물반출구	지역시료채취펌프 (SARA-5100)	1	10.00	20/06/18	불검출 [검출한계 0.002미만]	—
—	공시료	—	—	—	—	0개/100개시야	—
—	공시료	—	—	—	—	0개/100개시야	—

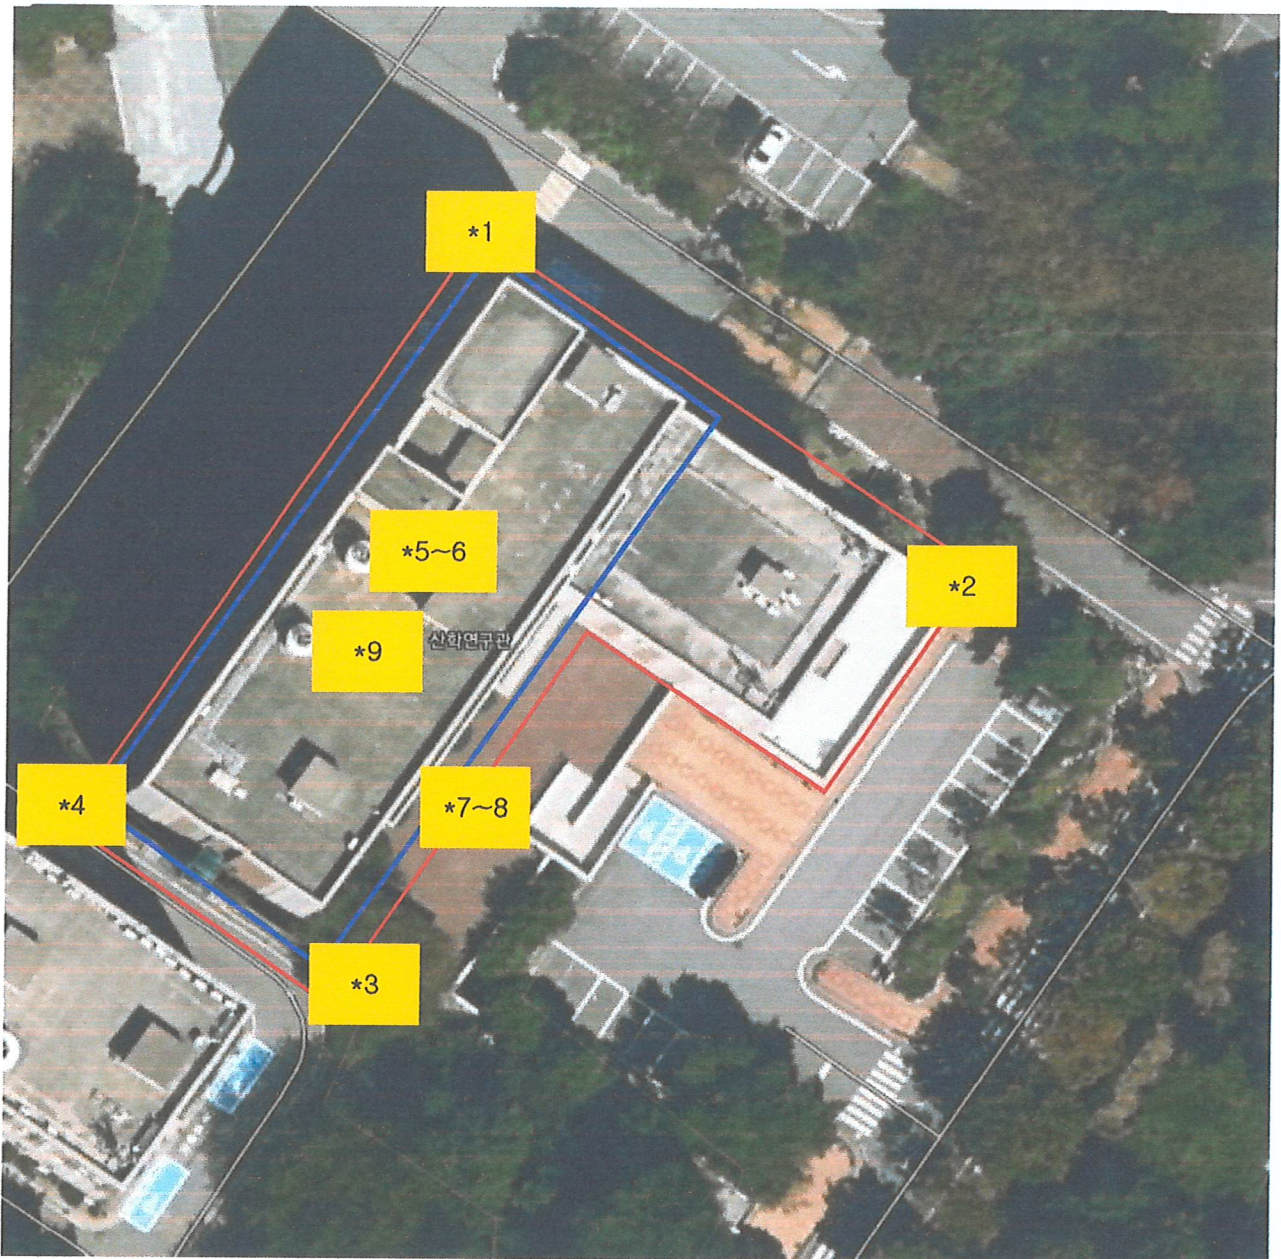
[별 첨 1] 측정 위치도(측정 장소)

시료 번호	측정 지점	측정 장비 (종류/수량)		유량 (ℓ/분)	측정 일시	측정 결과 (f/cc)	비고
1	부지경계선1	지역시료채취펌프 (SARA-5100)	1	10.00	20/06/19	불검출 [검출한계 0.002미만]	-
2	부지경계선2	지역시료채취펌프 (SARA-5100)	1	10.00	20/06/19	불검출 [검출한계 0.002미만]	-
3	부지경계선3	지역시료채취펌프 (SARA-5100)	1	10.00	20/06/19	불검출 [검출한계 0.002미만]	-
4	부지경계선4	지역시료채취펌프 (SARA-5100)	1	10.00	20/06/19	불검출 [검출한계 0.002미만]	-
5	위생설비입구	지역시료채취펌프 (SARA-5100)	1	10.00	20/06/19	불검출 [검출한계 0.002미만]	-
6	작업장주변	지역시료채취펌프 (SARA-5100)	1	10.00	20/06/19	불검출 [검출한계 0.002미만]	-
7	음압기배출구1	지역시료채취펌프 (SARA-5100)	1	10.00	20/06/19	불검출 [검출한계 0.002미만]	-
8	음압기배출구2	지역시료채취펌프 (SARA-5100)	1	10.00	20/06/19	불검출 [검출한계 0.002미만]	-
9	폐기물반출구	지역시료채취펌프 (SARA-5100)	1	10.00	20/06/19	불검출 [검출한계 0.002미만]	-
-	공시료	-	-	-	-	0개/100개시야	-
-	공시료	-	-	-	-	0개/100개시야	-

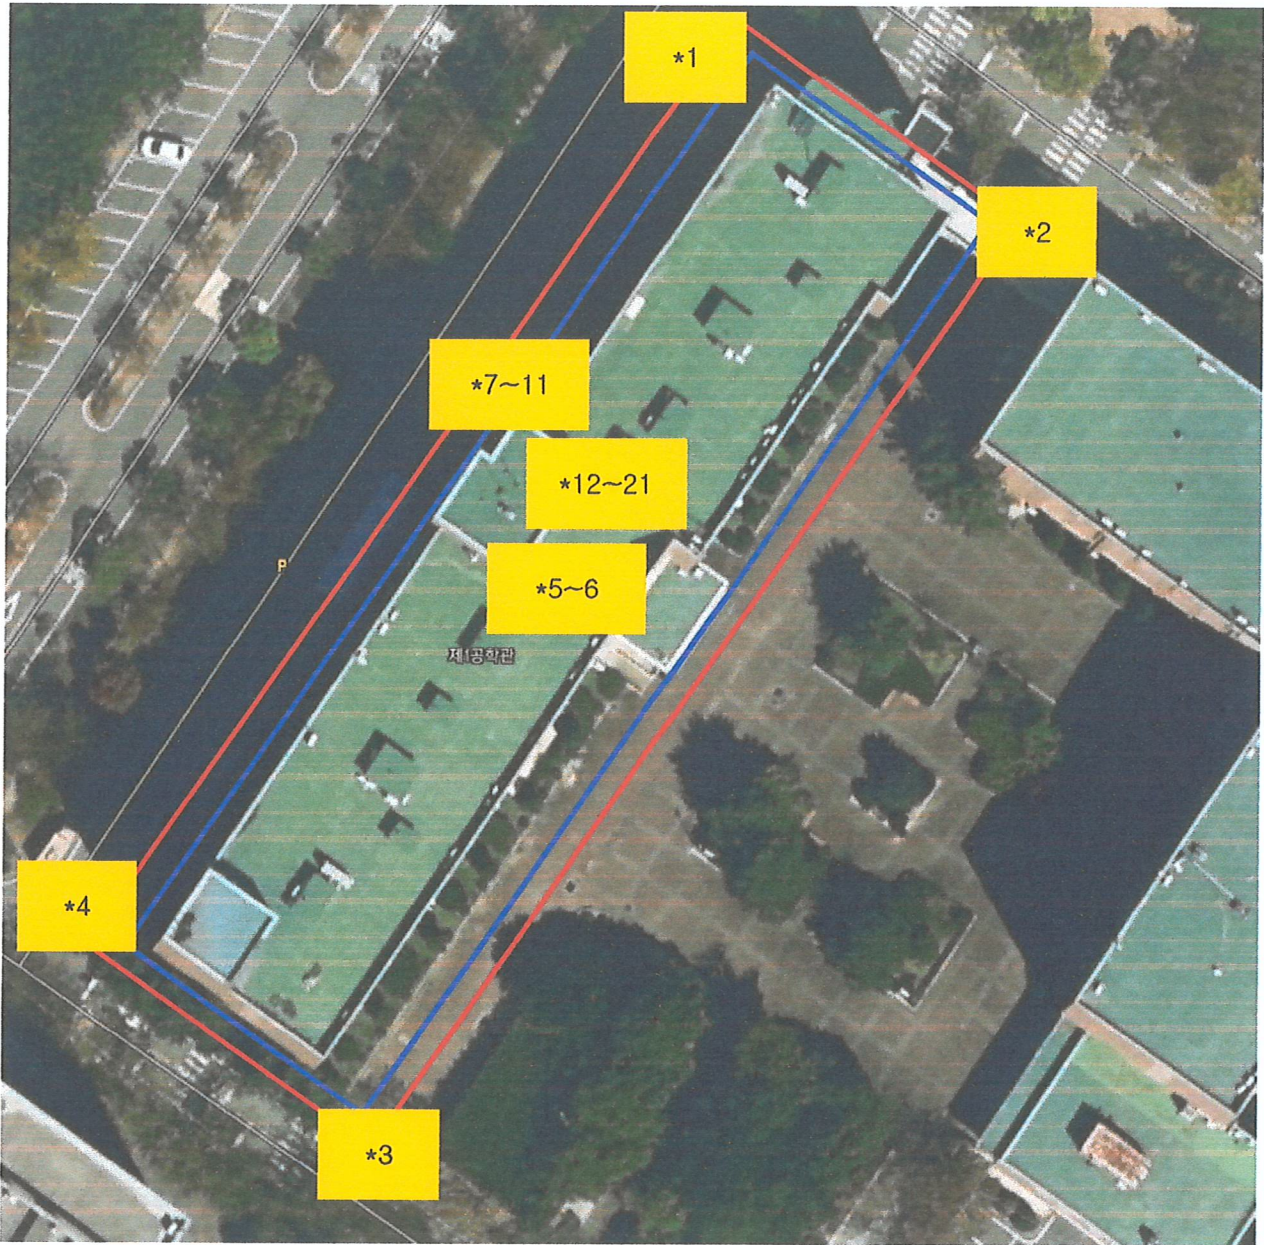
[별 첨1] 측정 위치도(측정 장소)

시료 번호	측정 지점	측정 장비 (종류/수량)		유량 (ℓ/분)	측정 일시	측정 결과 (f/cc)	비고
1	부지경계선1	지역시료채취펌프 (SARA-5100)	1	10.00	20/06/21	불검출 [검출한계 0.002미만]	—
2	부지경계선2	지역시료채취펌프 (SARA-5100)	1	10.00	20/06/21	불검출 [검출한계 0.002미만]	—
3	부지경계선3	지역시료채취펌프 (SARA-5100)	1	10.00	20/06/21	불검출 [검출한계 0.002미만]	—
4	부지경계선4	지역시료채취펌프 (SARA-5100)	1	10.00	20/06/21	불검출 [검출한계 0.002미만]	—
5	위생설비입구	지역시료채취펌프 (SARA-5100)	1	10.00	20/06/21	불검출 [검출한계 0.002미만]	—
6	작업장주변	지역시료채취펌프 (SARA-5100)	1	10.00	20/06/21	불검출 [검출한계 0.002미만]	—
7	음압기배출구1	지역시료채취펌프 (SARA-5100)	1	10.00	20/06/21	불검출 [검출한계 0.002미만]	—
8	음압기배출구2	지역시료채취펌프 (SARA-5100)	1	10.00	20/06/21	불검출 [검출한계 0.002미만]	—
9	음압기배출구3	지역시료채취펌프 (SARA-5100)	1	10.00	20/06/21	불검출 [검출한계 0.002미만]	—
10	음압기배출구4	지역시료채취펌프 (SARA-5100)	1	10.00	20/06/21	불검출 [검출한계 0.002미만]	—
11	음압기배출구5	지역시료채취펌프 (SARA-5100)	1	10.00	20/06/21	불검출 [검출한계 0.002미만]	—
12	폐기물반출구1	지역시료채취펌프 (SARA-5100)	1	10.00	20/06/21	불검출 [검출한계 0.002미만]	—
13	폐기물반출구2	지역시료채취펌프 (SARA-5100)	1	10.00	20/06/21	불검출 [검출한계 0.002미만]	—

14	폐기물반출구3	지역시료채취펌프 (SARA-5100)	1	10.00	20/06/21	0.003	—
15	폐기물반출구4	지역시료채취펌프 (SARA-5100)	1	10.00	20/06/21	불검출 [검출한계 0.002미만]	—
16	폐기물반출구5	지역시료채취펌프 (SARA-5100)	1	10.00	20/06/21	0.003	—
17	갱의실1	지역시료채취펌프 (SARA-5100)	1	10.00	20/06/21	불검출 [검출한계 0.002미만]	—
18	갱의실2	지역시료채취펌프 (SARA-5100)	1	10.00	20/06/21	불검출 [검출한계 0.002미만]	—
19	갱의실3	지역시료채취펌프 (SARA-5100)	1	10.00	20/06/21	불검출 [검출한계 0.002미만]	—
20	갱의실4	지역시료채취펌프 (SARA-5100)	1	10.00	20/06/21	불검출 [검출한계 0.002미만]	—
21	갱의실5	지역시료채취펌프 (SARA-5100)	1	10.00	20/06/21	불검출 [검출한계 0.002미만]	—
—	공시료	—	—	—	—	0개 / 100개시야	—
—	공시료	—	—	—	—	0개 / 100개시야	—
